MEMORANDUM

DATE: April 24, 2008

SUBJECT: Inspection Report for Summit, Inc. Addendum
6901 West Chicago Avenue/Industrial Highway, Gary, Indiana 46406

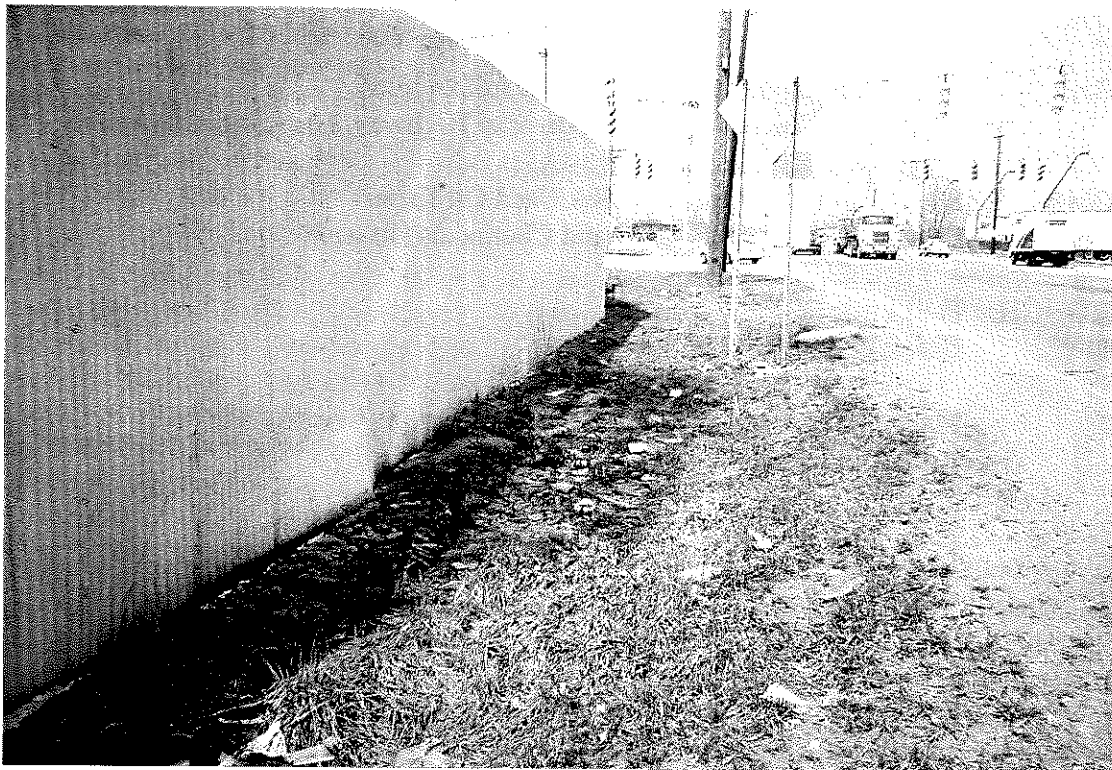
Compact Disk Image Number: 854430-R-023

Description of photograph: This photograph was taken facing northwest. The stoplight is for the intersection of Industrial Highway and Chicago Avenue. Note that the darkened grassy area extends beyond the fence's shadow, toward Industrial Highway on the right.

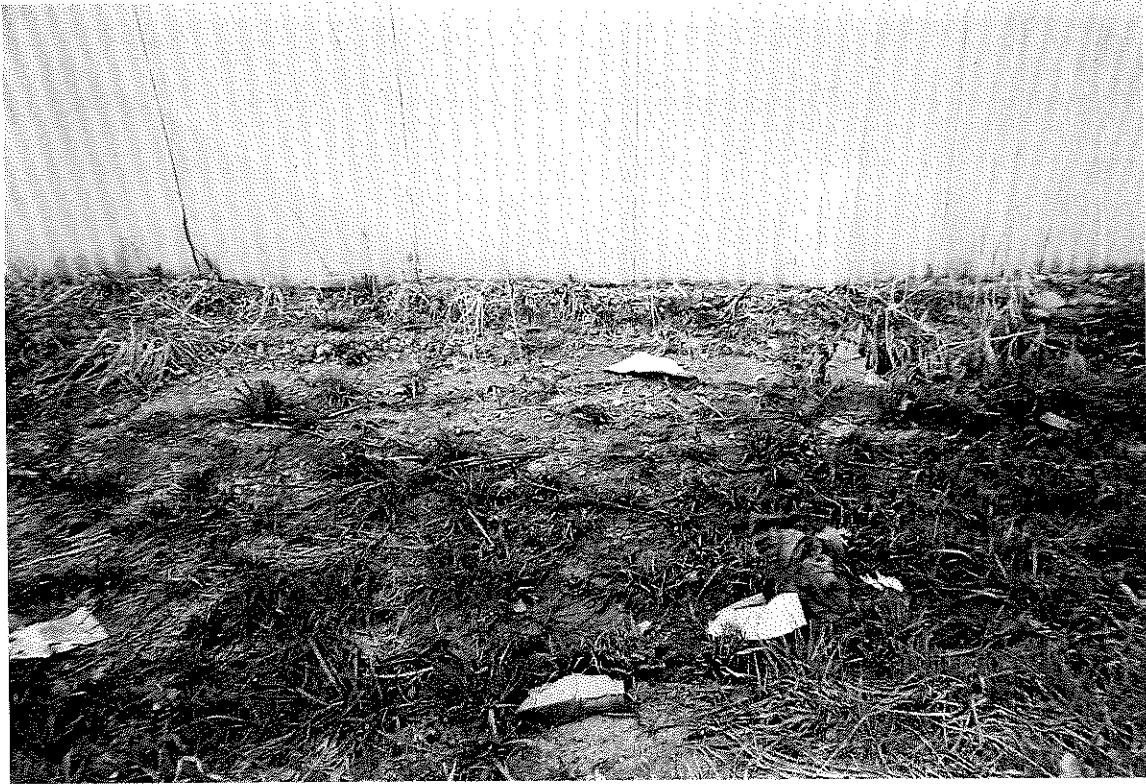
Compact Disk Image Number: 854430-R-022

Description of photograph: This photograph was taken facing southwest and looking down at the oily dirt on the grass. The outer margin of a puddle, apparently on both sides of the fence, is indicated by the oily film on the grass and dirt.

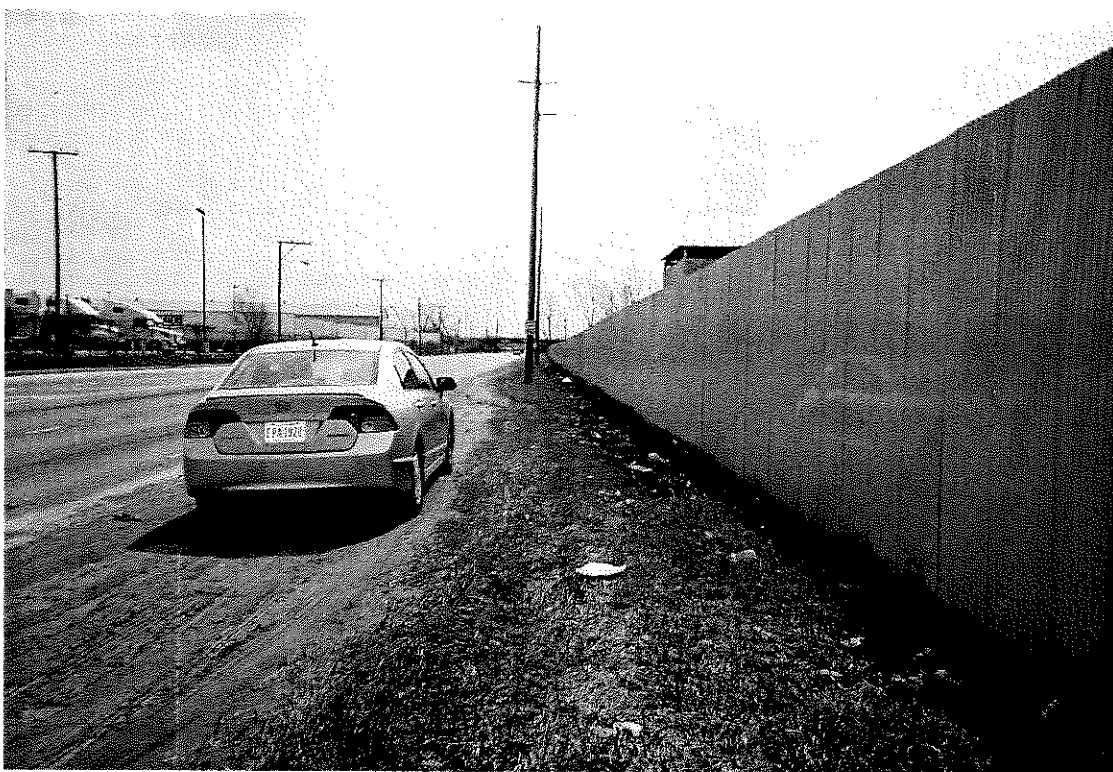
Compact Disk Image Number: 854430-R-021

Description of photograph: This photograph was taken facing southeast along Industrial Highway with Summit Inc.'s privacy fence on the right. Additional signs of oil releases are to the southeast of photos 23 and 22 and extend toward Industrial Highway farther than the fence's shadow. The shed where gasoline was removed from cars on April 2, 2008, is visible over the fence.

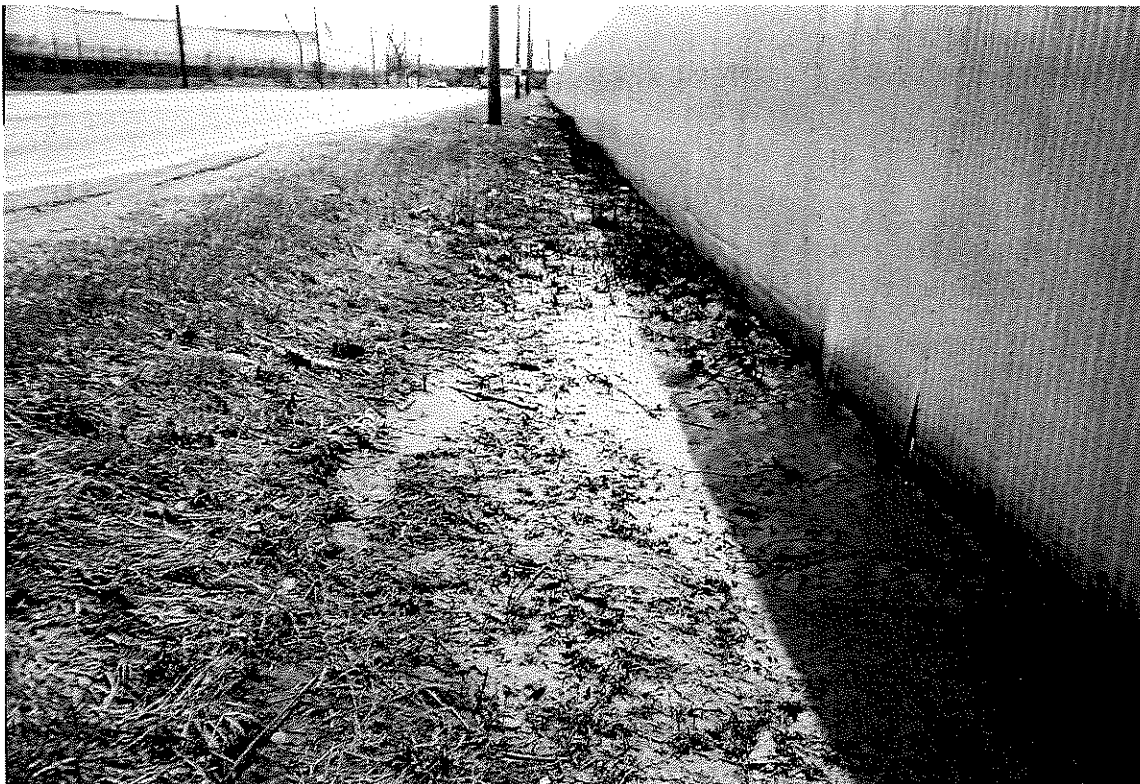
Compact Disk Image Number: 854430-R-020

Description of photograph: This photograph was taken facing southeast and looking down at the oily dirt on the grass. Note the oily waste residue remaining on the ground as the puddle dries up. The width of the puddle in the ditch corresponds to the height of the oil line on the fence. Also, note the space between fence sections allowing flow from one side to the other.

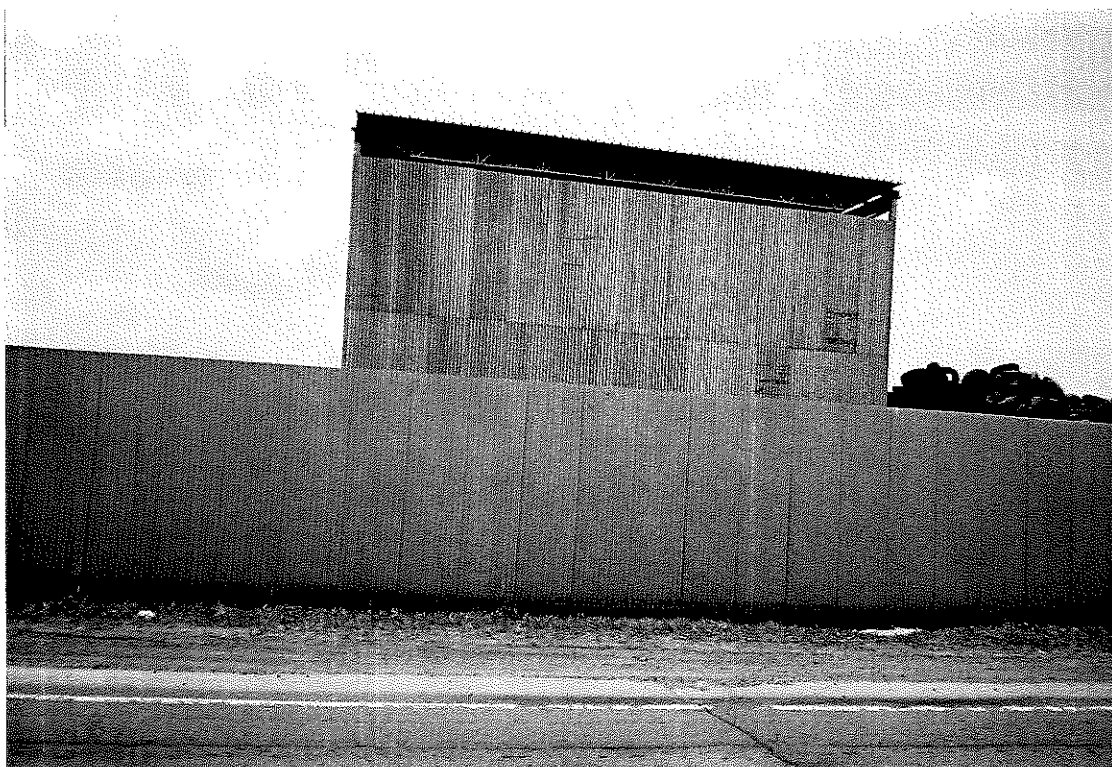
Compact Disk Image Number: 854430-R-019

Description of photograph: This photograph was taken facing southwest from the middle of Industrial Highway from a location northeast (perpendicular to the fence) of the photographer's location for taking photo 20.
